Investigation of gypsum after high temperature exposure

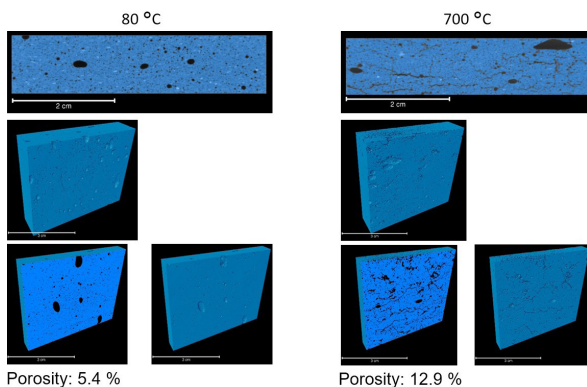
Slice of the gypsum treated at 700 °C a) before and b) after differentiation of air and gypsum. The air is colored in green while the gypsum is colored in violet.

A series of five gypsum samples exposed to temperatures ranging from 80 °C to 700 °C was studied using X-ray CT. Then, image analysis was used to differentiate between the air, in dark, and the gypsum, in bright. By that, the porosity (fraction of air in respect to the total volume) could be determined. With increasing temperature, an increase in porosity could be seen. In addition, the visual inspection of the scan revealed cracks in samples treated above 300 °C.
